Edelweiss Community Wildfire Risk Assessment May 2024

Okanogan Conservation District

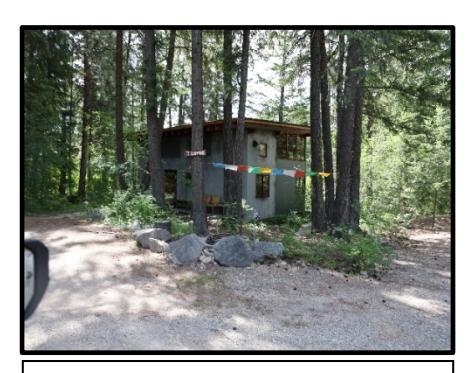
Driveways that allow access to two sides of the home are beneficial when large turnarounds are not feasible or present.

For the lots with the longest (300'+) driveways, ensure there are turnarounds at each residence as needed.

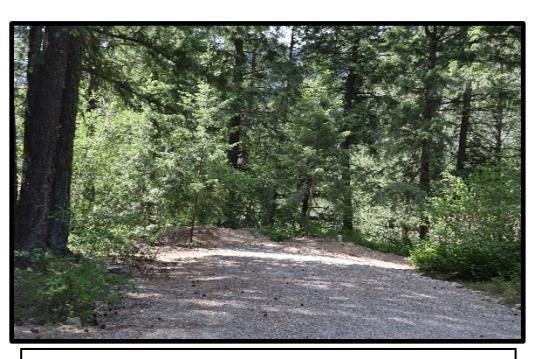
Vegetation growing up along the roadside like this need to be maintained throughout the year.

Prune trees along roads to 14' high for fire truck access. Consider signage on steeper drives discouraging use by larger vehicles.

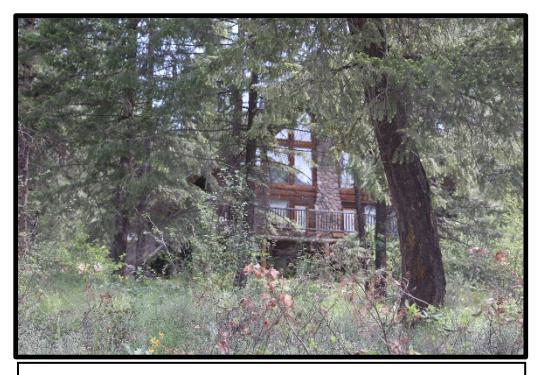
This home would benefit from increased fuels reduction in all three home ignition zones.

Continue to reduce the number of trees, especially around homes and heavily wooded lots to reduce the likelihood of a running crown fire consuming the trees in the development by creating space between tree canopies. Maintain a low level of ladder fuels and woody debris on the forest floor. Keep meadow grasses near homes and roadways low during fire season. Grasses that are mowed once dormant will not regrow until moisture returns in the fall. Irrigated grasses which are kept green will be less likely to ignite. Ideally, these management actions will keep fire on the ground. Areas with deep duff can be mitigated by raking and removing some of this material, especially around homes and large trees.

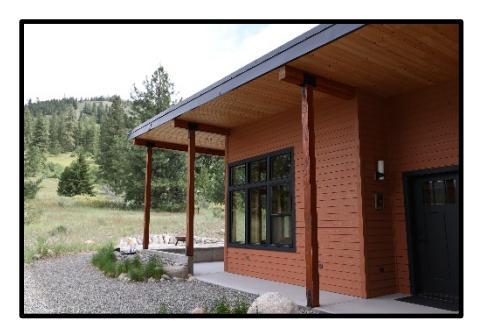
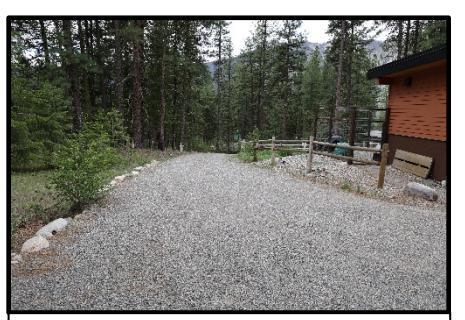
This home has incorporated many of the recommended Firewise principles to increase its survivability if exposed to a wildfire.

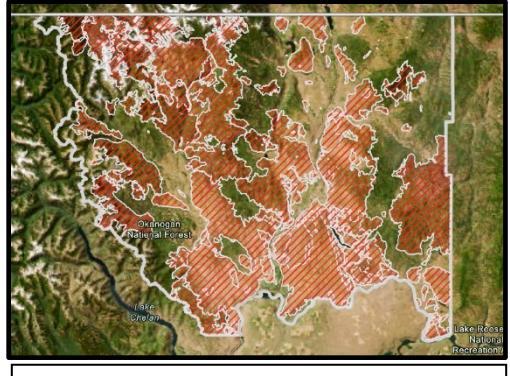
Previously burned areas are in red.

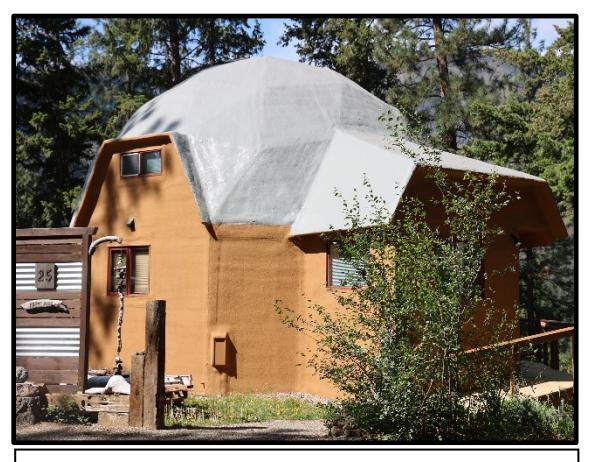
This home utilizes stucco as opposed to wood siding susceptible to ember ignition.

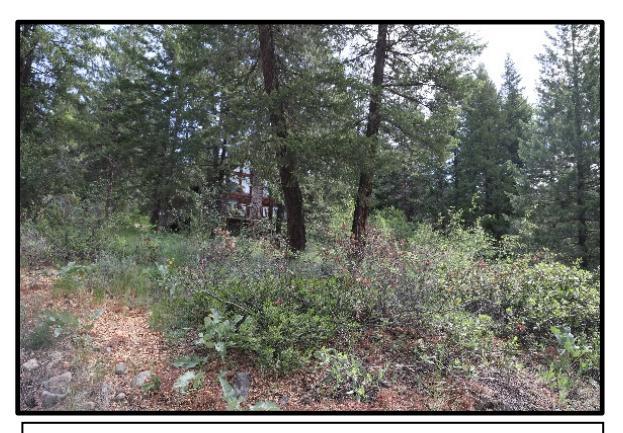
Homes on steep slopes such as this need an increased non combustible zone to mitigate the slopes effect on fire behavior.

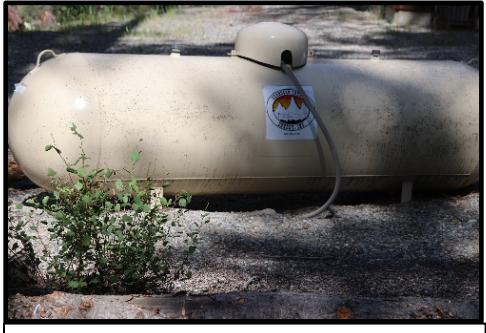
This propane is distanced properly from the home and has an adequate gravel base.

LPG tanks should be located at least 30 feet from

structures and have fuel breaks around the tanks to prevent direct flame contact during a wildfire.
