PROFESSIONAL RESERVE STUDY

Edelweiss

20 Mustard Mountain Road, Winthrop, WA 98862

October 28, 2024

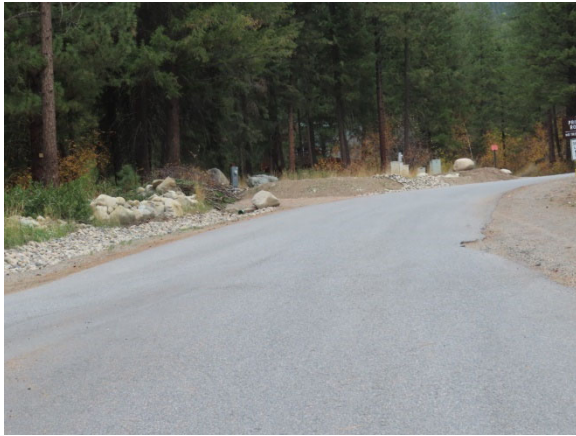
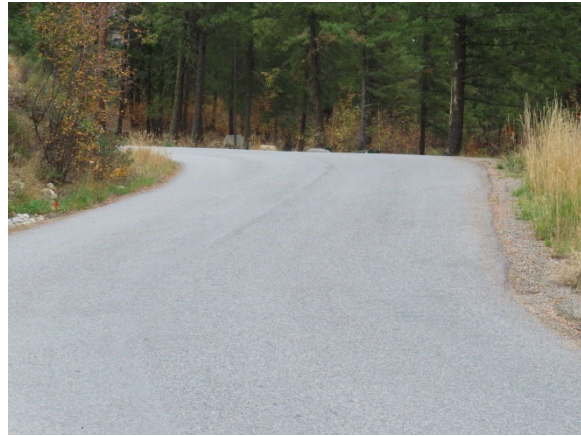
Main Entrance on Highland Road is Asphalt

The small asphalt area at the main entrance on Highland Road. This asphalt extends approximately 50 feet past the intersection of Highland Road and Homestead Road onto Highland Road and approximately 250 feet past this intersection onto Homestead Road. We understand that this asphalt was originally laid in 1995 and overlaid in 2005.

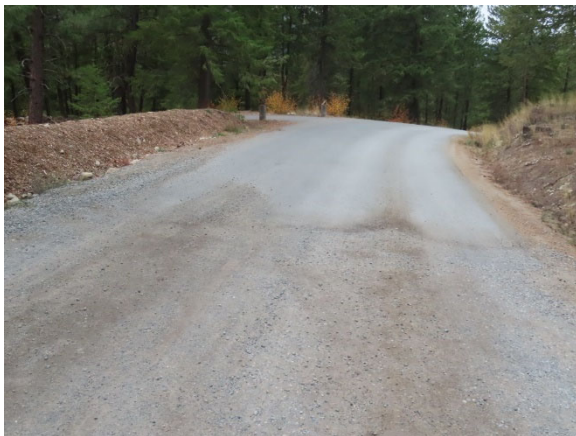
Highland Road/Homestead Road Transition Road is Asphalt

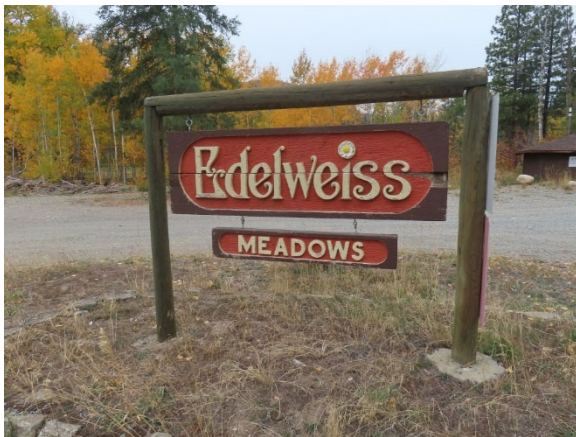
Meadows Property Sign

There are two property signs in this association; a Highland sign and a Meadows sign. These signs are constructed of wood supports and a wood panel hanging sign. The Highland sign has wood shake roofing, while the Meadows sign has a wood cross member. We understand that these signs were installed in 2017. We have assumed that these signs will be generally maintained via routine maintenance and general operations. With maintenance, we have assumed that these signs will have a long 30-year lifespan.

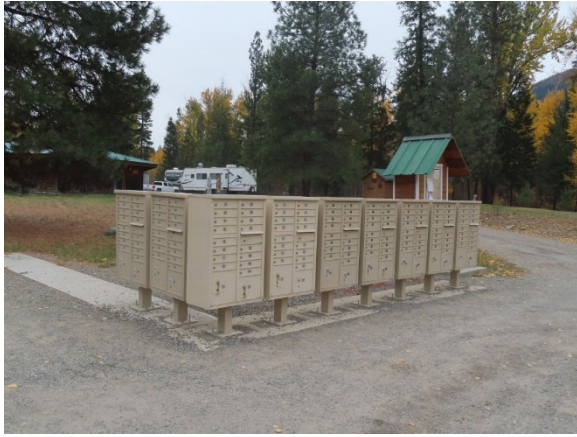
Mailbox Bank

There are 9 metal mailbox kiosks installed in the Meadows campground area of the development that were installed in 2018. These mailbox kiosks have a typical lifespan of 20 years.

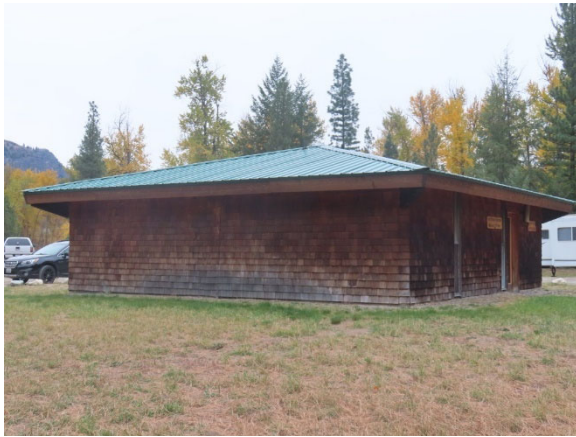
Campground Bathroom House and Laundry Room

There are large eaves on this building; therefore, if the siding is periodically cleaned and stained with spot shake replacement, it should have a lifespan beyond the 30-year duration of this study. We have budgeted for cleaning, staining, and spot siding/trim replacement every 10 years.

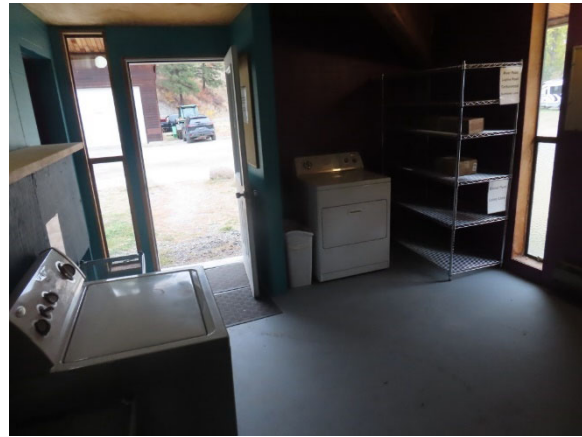
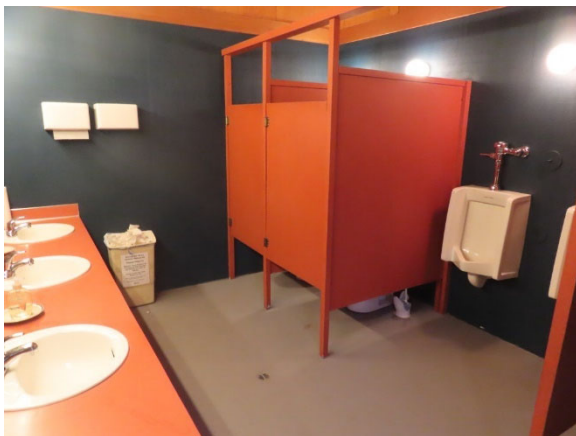
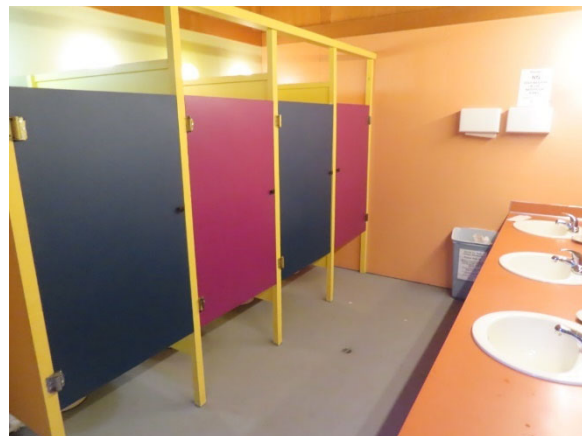
Interior of Campground Bathroom House and Laundry Room

Men's Bathroom

Women's Bathroom

The bathrooms and laundry room in this building are simple interior areas with bare concrete floors. We have budgeted for renovation of the interior of this building in the distant future and every 20 years thereafter.

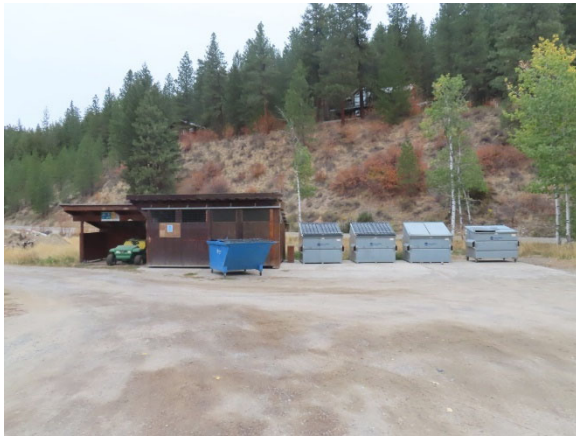
Exterior of Garbage/Recycling Center

There is a garbage/recycling center located at the campground. We have budgeted for exterior cleaning, staining, and spot siding/trim replacement of this building every 10 years.

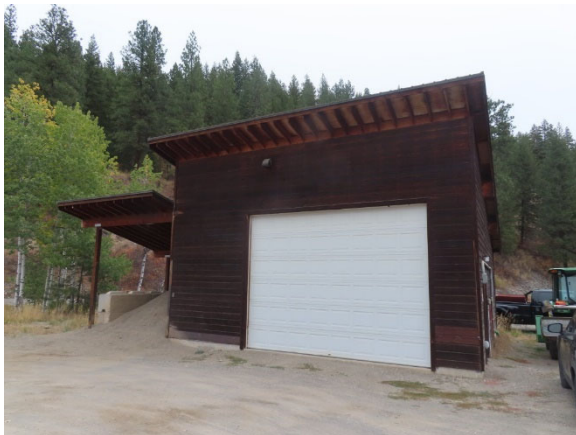
Exterior of Maintenance Building with Sand Shed

The roof of this building should have 50-year design life, which is well beyond the 30-year duration of this study. Therefore, no funding has been budgeted for roofing of this building.

There are large eaves on this building; therefore, if the siding is periodically cleaned and stained with spot shake replacement, it should have a lifespan beyond the 30-year duration of this study. We have budgeted for cleaning, staining, and spot wood replacement every 10 years.

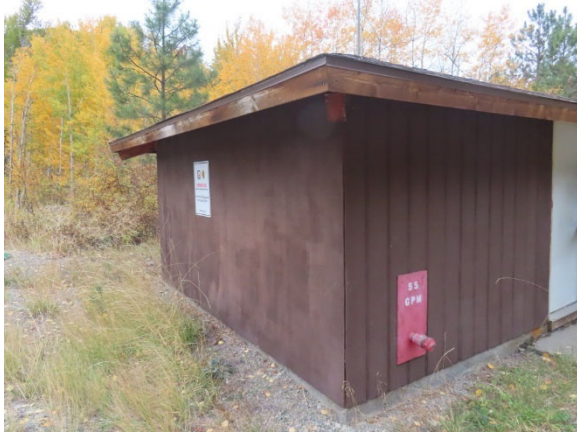
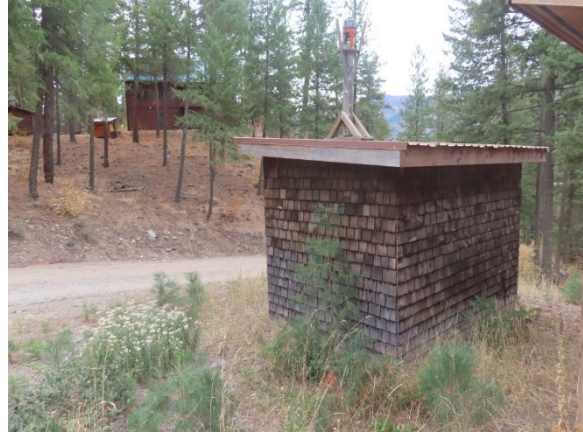
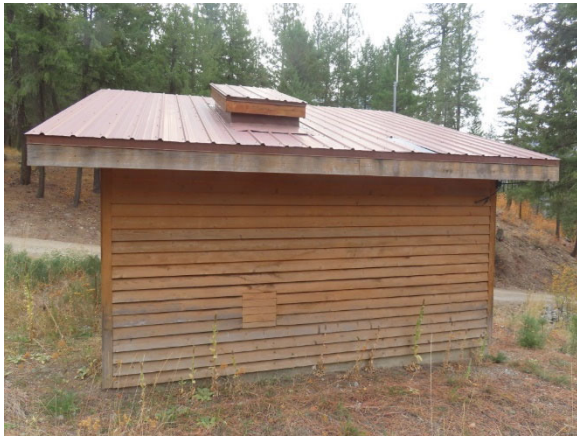
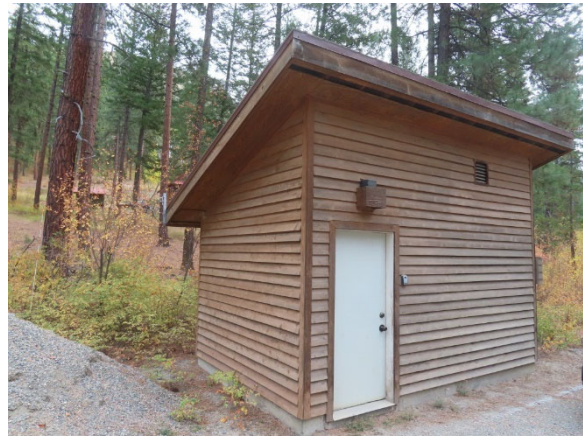
Campground Well House

Cassal Well House

Cassal Booster Pump House

Highland Booster Pump House

There are several pump houses in this development with wood siding and a combination of metal roofing and asphalt composition roofing. These buildings are simple, and we have assumed that all maintenance including roofing and exterior siding maintenance will be paid for as necessary via the general operating budget.

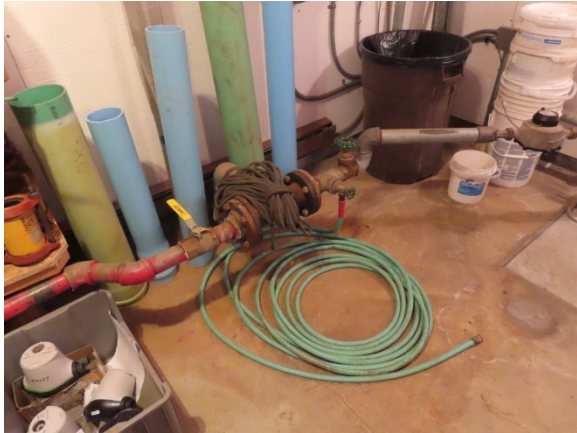
Interior of Campground Well House

The Campground well pump is a 5-hp pump that was installed in 2011. We have also estimated that this pump will need to be replaced every 20 years.

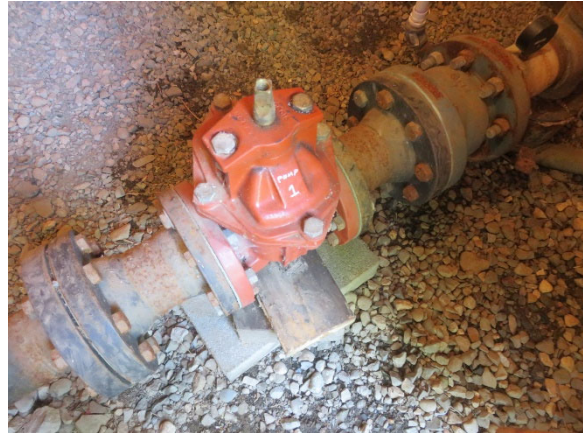
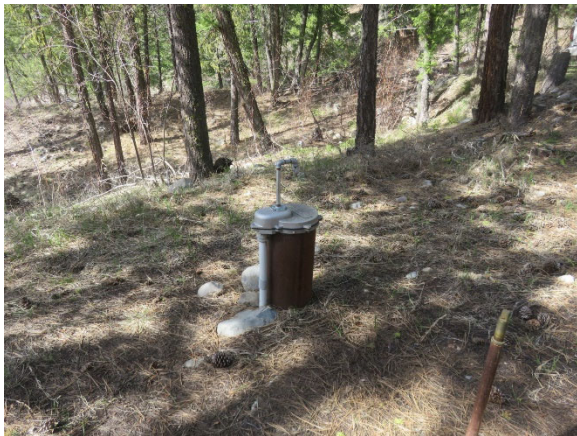
Cassal Pump 1

Cassal Well Head 2

There are two Cassal well pumps (Pumps 1 and 2) that are each 10 hp. Pump 1 was replaced in 2008 while Pump 2 was replaced in 1999. We have assumed that each of these pumps be replaced on a 20-year cycle. However, it may also be possible to rewind these pumps and get additional life (though we have not included this in our budget).

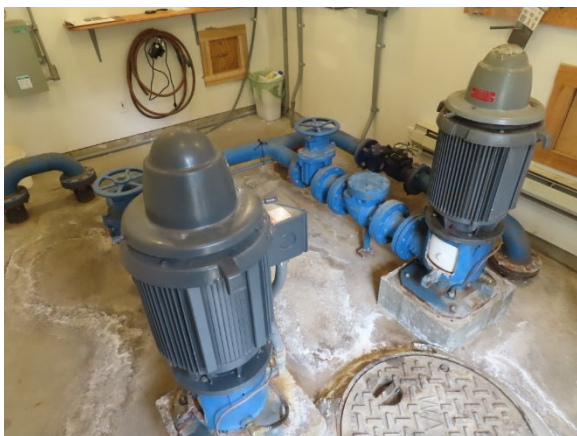
Cassal Booster Pumps

There are two separate booster stations in the Cassal system; the Cassal booster station (two 20-hp pumps) and the Highland booster station (two 7 1/2-hp pumps). We understand that Highland booster pump 1 was replaced in 2020 and Highland booster pump 2 was replaced in 2024, while the rest of these pumps are at least 20 years old; however, the motor to Cassal Booster Pump 2 was rebuilt in 2017. We recommend that all of these pumps be budgeted for replacement within the next 6 years, and every 20 years thereafter.

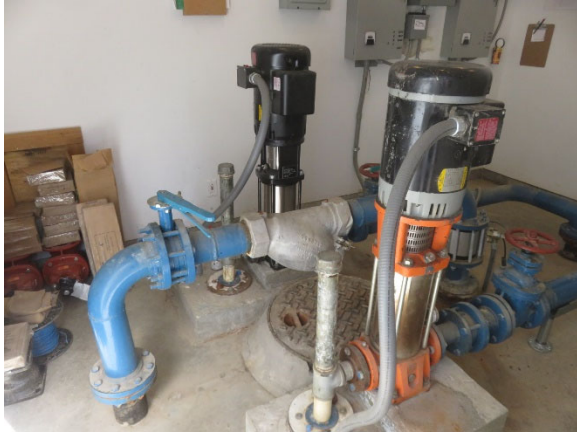
Highland Booster Pumps

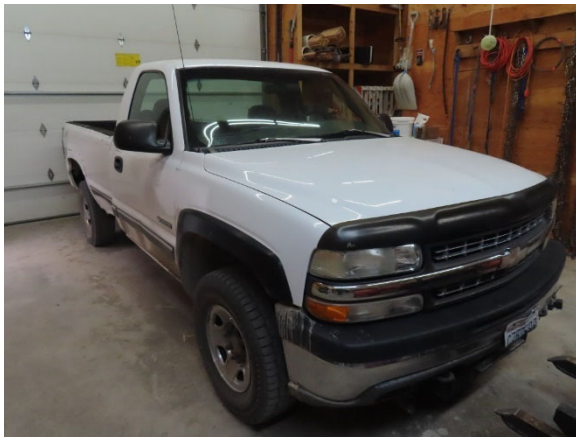
Chevy 2500 Pickup Truck

The homeowners association owns one Chevy 2500 pick-up truck and one Ford F-350 diesel crew cab pick-up truck. We understand from Pitkin Thomas that the Board plans to sell both of these trucks and purchase one truck for \$38,000, which clearly assumes that this truck will be used when purchased. We have assumed that the association will purchase a new truck every 15 years.

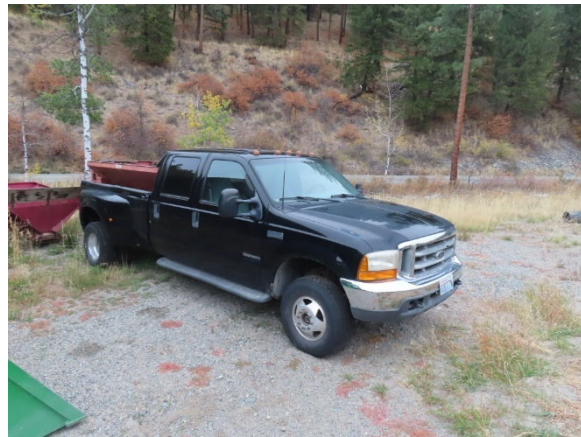
Ford F-350 Diesel Crew Cab Pickup Truck

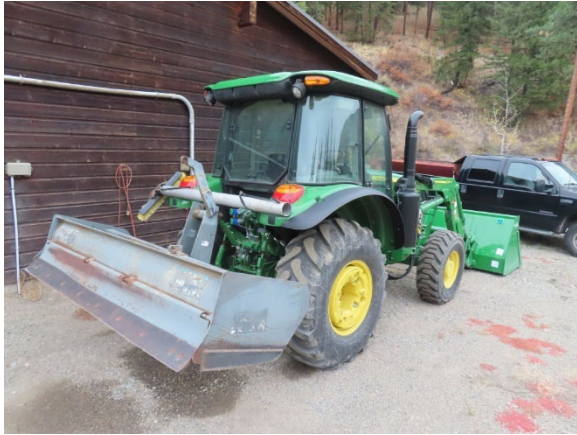
Tractor

We assume that the new machine will have a total lifespan of 20 years before replacement is necessary.

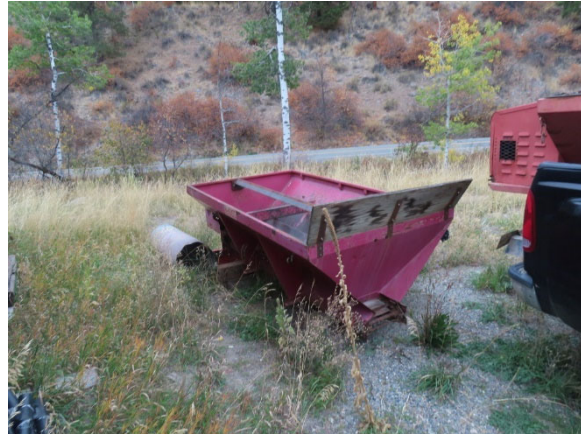
Sand Spreader

There are two sand spreaders that are somewhat worn as well as a plow. We have assumed that these sand spreaders and plow can be maintained as necessary indefinitely. Additionally, we have assumed that all smaller maintenance equipment will be paid for via the general operating budget, as necessary.

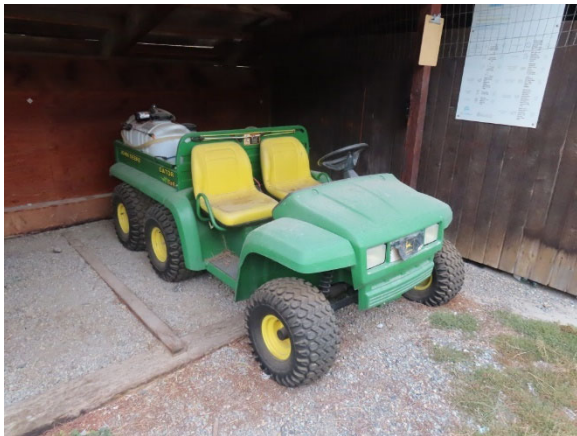
Gator ATV

The Association owns a Gator ATV that we assume will have a total lifespan of 10 years.

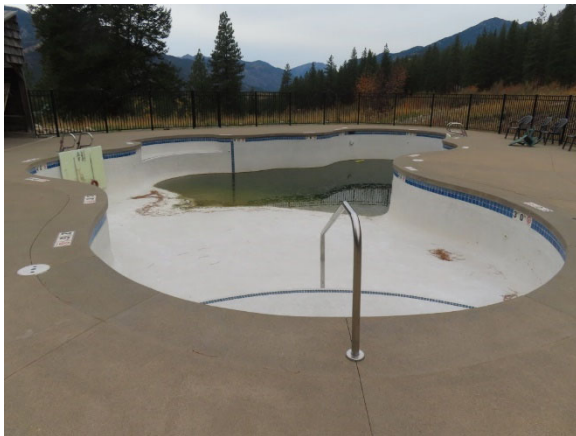
Swimming Pool

3.8	SWIMMING POOL								
	Replaster and re-tile the swimming pool	2,400	SF	\$35	11	18	\$84,000	\$289	\$16.04
	Replace the swimming pool heat pump	1	EA	\$7,200	3	10	\$7,200	\$25	\$2.47
	Pool house interior renovation	1	LS	\$9,600	10	20	\$9,600	\$33	\$1.65
	Clean, stain, and spot siding replacement of the pool house	1	LS	\$7,000	3	10	\$7,000	\$24	\$2.41
	Picnic and patio furniture allotment at swimming pool	1	LS	\$10,000	3	10	\$10,000	\$34	\$3.44
	<i>Swimming pool filters, pumps, and chlorination equipment are maintained by on-site staff and paid for via the general operating budget</i>								
Average Cost Per Unit Per Year									\$583

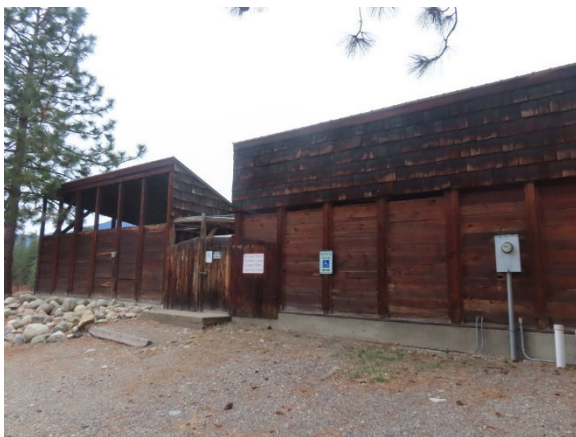
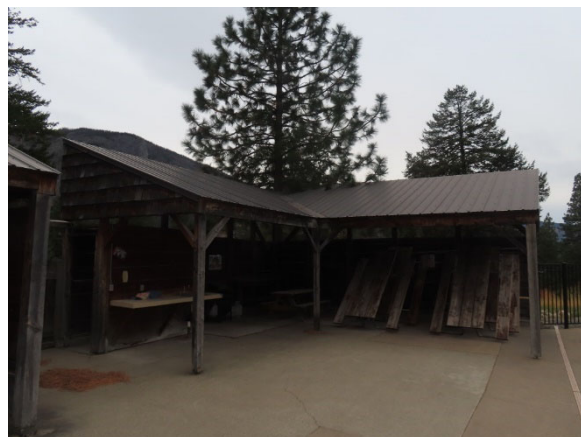
Swimming Pool House

The roof of the pool house building is a metal shed roof and should have 50-year design life, which is well beyond the 30-year duration of this study. Therefore, no funding has been budgeted for roofing of this building. We have not budgeted for siding/wood wall replacement. If the siding/wood wall is periodically cleaned and stained with spot siding replacement (as necessary), the siding should have a lifespan beyond the 30-year duration of this study. We have budgeted for cleaning, staining, and spot wood replacement every 10 years.

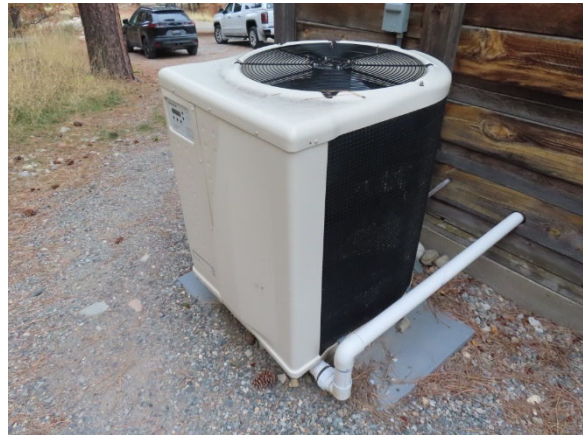
Swimming Pool Heat Pump
