Edelweiss Community Wildfire Risk Assessment May 2024

Okanogan Conservation District

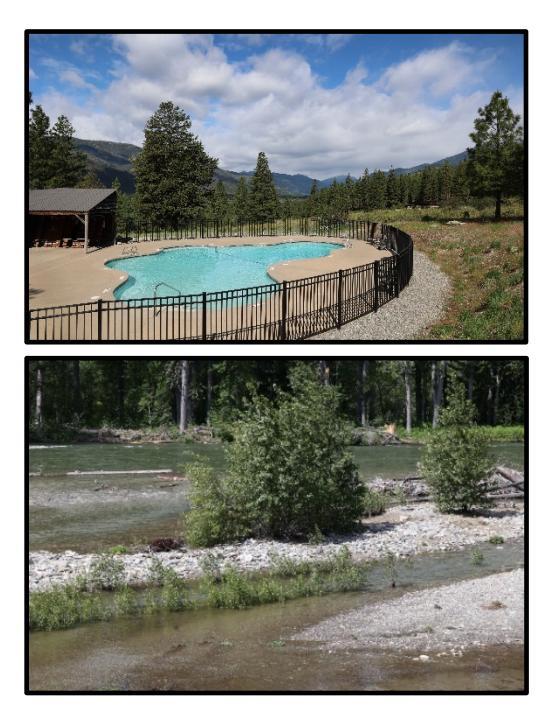
Edelweiss has a variety of vegetation grouped along elevation lines or along the river containing the following: Central Rocky Mountain Dry Mixed Conifer Forest and Woodland, specifically a Douglas Fir/Ponderosa Pine Forest above the river with Central Rocky Mountain Black Cottonwood Riparian Forest near the river. The shrub layer is variable across the area, but it's mostly small patches of sagebrush and bitterbrush intermixed with native grasses. Some areas of non-native cheat grasses have also become established. Much has been accomplished within the community since the 2018 assessment in regards to vegetation density. Large portions of the community have completed a considerable work in removing small diameter timber and shrubs which have addressed a number of the concerns from previous years. In the past five years, 86.8 acres

of fuels treatments have been completed through the DNR Cost Share Program. There is one drainage between Cassal and Bitterbrush Rd. that would benefit from additional thinning. This continuous line of timber runs from Goat Creek Rd. uphill through the community and would directly impact multiple homes if a fire were to start here. Work in this drainage is expected to begin soon and will be completed within the next 18-24 months.

Continue to reduce the number of trees, especially around homes and heavily wooded lots to reduce the likelihood of a running crown fire consuming the trees in the development by creating space between tree canopies. Maintain a low level of ladder fuels and woody debris on the forest floor. Keep meadow grasses near homes and roadways low during fire season. Grasses that are mowed once dormant will not regrow until moisture returns in the fall. Irrigated grasses which are kept green will be less likely to ignite. Ideally, these management actions will keep fire on the ground. Areas with deep duff can be mitigated by raking and removing some of this material, especially around homes and large trees.

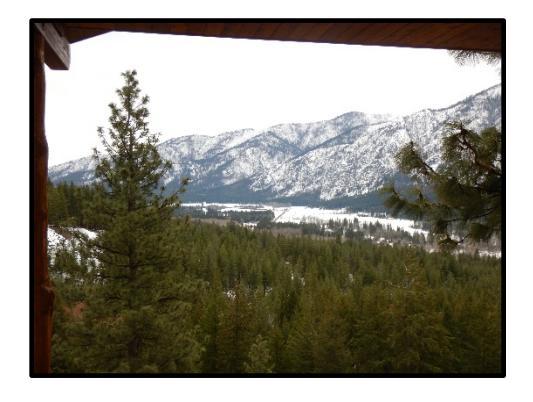
Owners whose property backs up to the steepest slopes should be aware that burning material often

rolls downhill during wildfire events. Efforts should be made to reduce the likelihood that any of this rolling material could contact the home or fuels that lead to the home. Drainages that are thick and overgrown can burn hot and move up slope. Property owners should be aware of fire movement and have a defensible space around the home. Homeowners who have not yet received an assessment, will require individual risk assessments to properly advise actions to mitigate this specific concern.
