Edelweiss Master Roads Plan Update

Prepared by:
Edelweiss Roads Committee

May, 2025

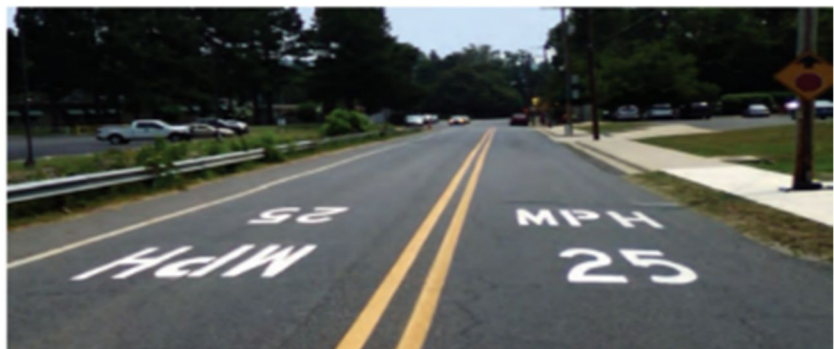
FIGURE 2. EXAMPLE OF SPEED LIMIT ON PAVEMENT

Potential improvements to the current speed limit signs were considered. One option is to use lettering on the paved section near the entrance similar to Figure 2. This option was thought to be infeasible due to no local contractor, and the presence of sand would soon erase/obscure the lettering.

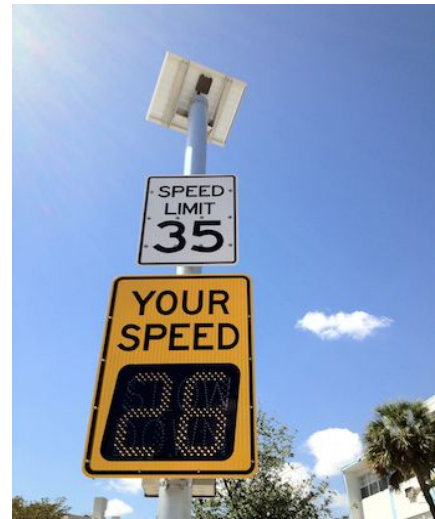
FIGURE 3. EXAMPLE OF RADAR SPEED FEEDBACK SIGN

Another option is to install a radar speed feedback sign similar to Figure 3 Radar Speed Feedback sign. Research indicates these devices may be effective at reducing vehicle speed. The cost to buy a radar speed-feedback unit is about \$3,600 or about \$400 to rent for one month. There may be opportunities to share costs with one or more other Homeowner Associations (HOAs) in the Methow Valley. Due to the high costs of the radar speed signs, this option was not considered practical, at this time, without the cooperation of other HOAs
